Test Report

No. XMNML2000952701

The following sample(s) was/were submitted and identified on behalf of the clients as : Carbide rod

Material : Carbide grade BT55

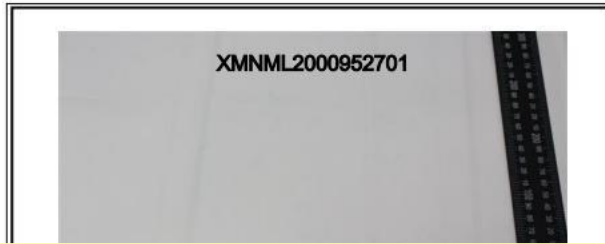
Sample photo:

Specimen No.	SGS Sample ID	Description
SN1	XMN20-009527.001	Dk-grey surfaced metal rod
